RE: Kolomoki: Spring Creek Mitigation Area  
Year 3 Wetland Monitoring Report  
USACE Permit 200410120  
Applicant: Kolomoki Farm, LLC

**Kolomoki Mitigation Bank, Spring Creek Mitigation Area**  
**Third Year Wetland Monitoring Report**  
**(Quantitative Analysis)**

**January 2012 through December 2012**

**KOLOMOKI MITIGATION BANK  
SPRING CREEK MITIGATION AREA  
Third Year Wetland Monitoring Report**

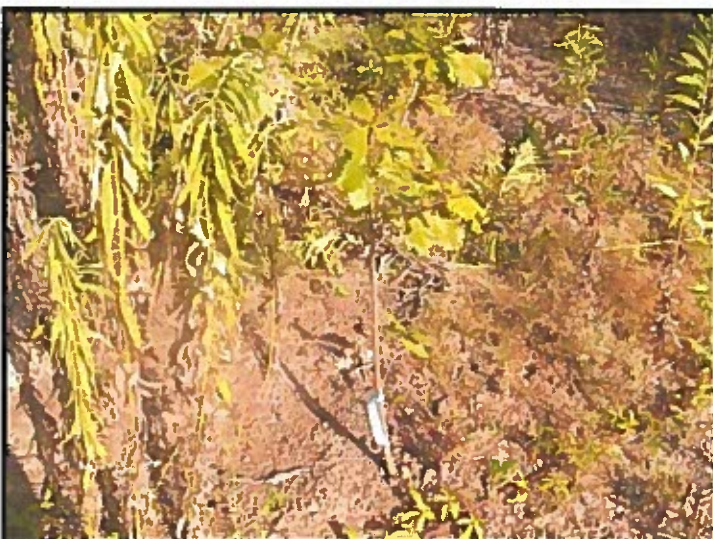
Photo 41 – Representative photo of healthy swamp chestnut oak.

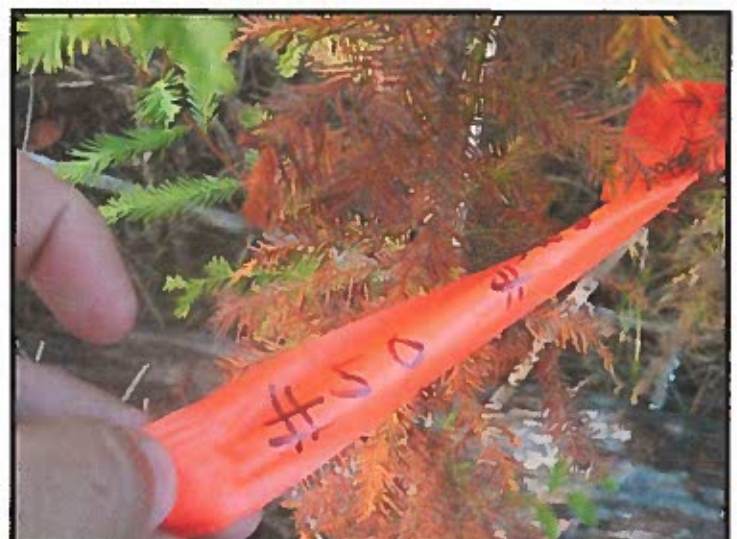
Monitoring Stations 1, 4, 5, 6, 10, and 12 meet or exceed the Y3 density requirements (225 trees/acre). MS 2 is slightly below (7%) the Y3 density requirement at 210 trees/acre. MS 3 is at 70% of the density requirements. Bald cypress (*Taxodium distichum*) and oaks (*Quercus* spp.) had the most loss of individuals over the last three years. Significant regeneration of green ash (*Fraxinus pennsylvanica*), red maple (*Acer rubrum*), button bush (*Occidentalis cephalanthus*), and bald cypress was observed throughout the SCMA. Currently, there is an average of 1:1 ratio of planted vs. volunteer trees throughout the monitoring stations.

Photo 42 – Representative photo of stressed bald cypress within MS-5.

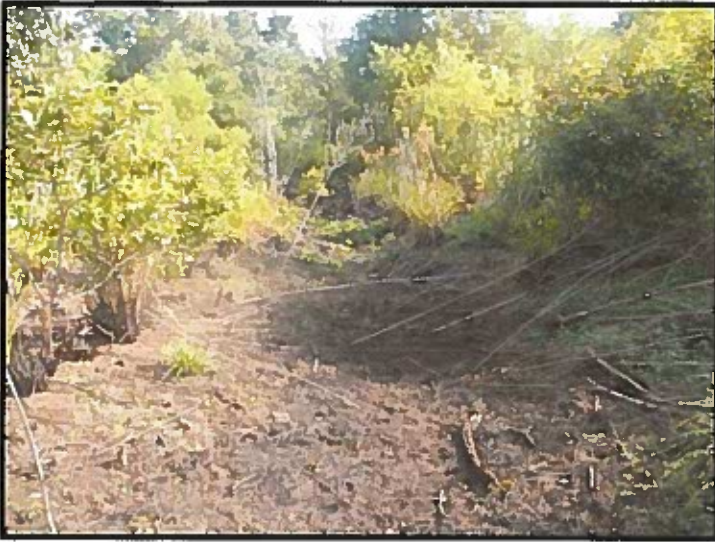
During 2012, there was an annual rainfall deficit of approximately four inches. Although the rainfall increased from the previous year (-18.69" to -4.45"), the intermittent and perennial streams remained dry. Dry conditions also prompt local farmers to withdraw more groundwater to irrigate their crops. Even though the wetland soils work to hold water, many of the wetland stations remained dry throughout the growing season. SL2 and the reference well experienced the wettest conditions during early spring (Feb-April) 2012. This is likely in response to the wettest month of the year falling in March with just over 7 inches of rain and limited to no irrigation demands for crops.

Photo 43— Dry drainage near wetland MS-10.

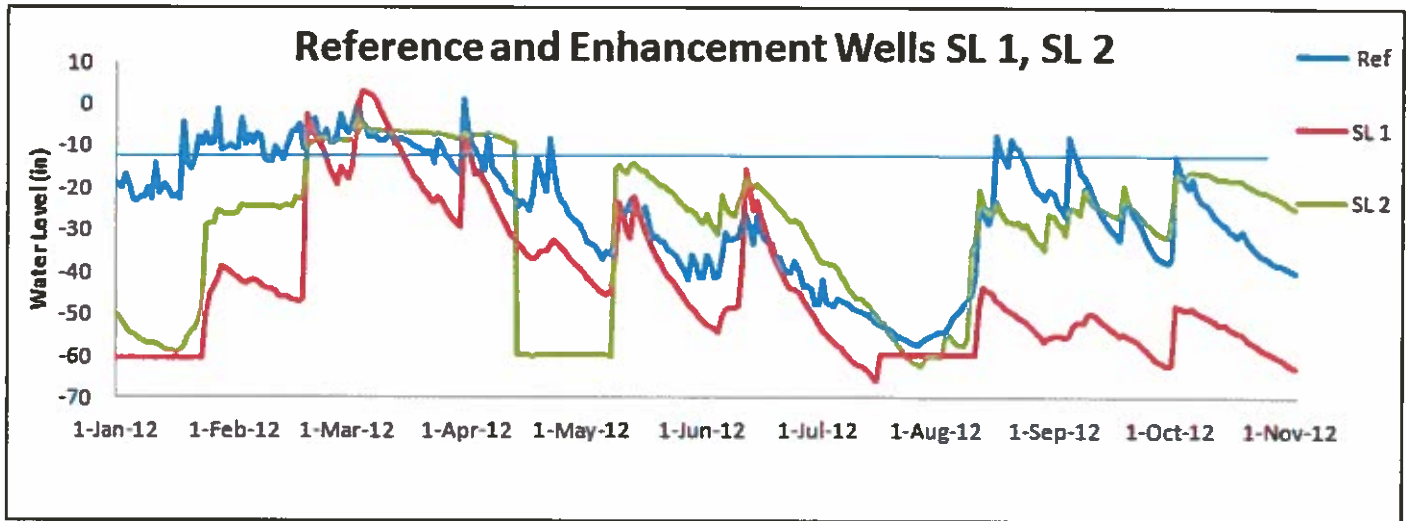
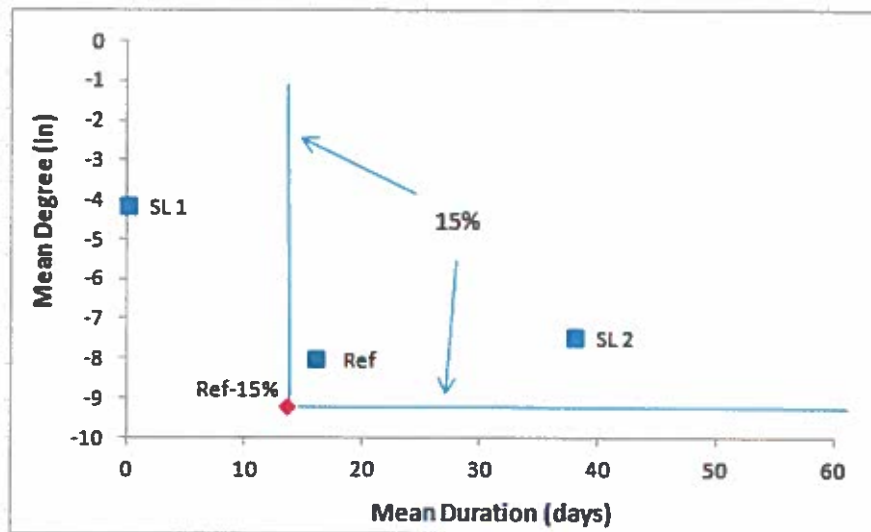
Appendix D  
Year 3 - Monitoring Well Data  
2012

The ground water data from the monitoring wells are shown in Appendix D; daily measurements of ground water depth are shown for January 1, 2012 through November 2, 2012. Monthly rainfall records for the same period show a rainfall deficit of approximately 6.5” (Appendix D). The Dry Creek reference well and monitoring well SL2 had surface inundation or saturation of the upper 12 inches for at least 14 consecutive days during the growing season (February 23 through December 2) and SL1 had surface inundation or saturation of the upper 12 inches for 13 consecutive days during the growing season. SL1 averaged 43.00 inches below the surface level, SL2 averaged 30.00 inches, and the reference well averaged 25.00 for the year. SL2 was within 15% of periodicity, duration, and degree of the reference well.

SL1 fell short of meeting the standard ACOE hydrology criterion by one day and less than 2 inches. SL1 did have three periods (6, 13, and 2 days) in the growing season where the water was at or above -12.0" and 5 of those days the water was ponded. SL2 experienced one period (45 days) where the water was at or above -12.0" with most of the days water averaged -

7.5”. The reference well had four periods from January through April with a total of 65 days where the hydrology criteria were met and the water depth averaged -8.0”.
